NASA/TM-2009-215955

# Experimental Behavior of Fatigued Single Stiffener PRSEUS Specimens

*Dawn C. Jegley  
Langley Research Center, Hampton, Virginia*

December 2009

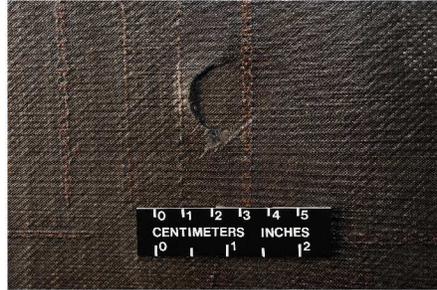
Figure 7. Machining damage to specimen F4.

Prior to delivery to NASA the OML of specimen F4 was damaged during the machining process. A photograph of this damage is shown in figure 7. The dent is approximately circular with a 1-inch diameter and the maximum depth is approximately 0.1 inches. No damage at this location is visible on the stiffened or Inner Mold Line (IML) side of the specimen.

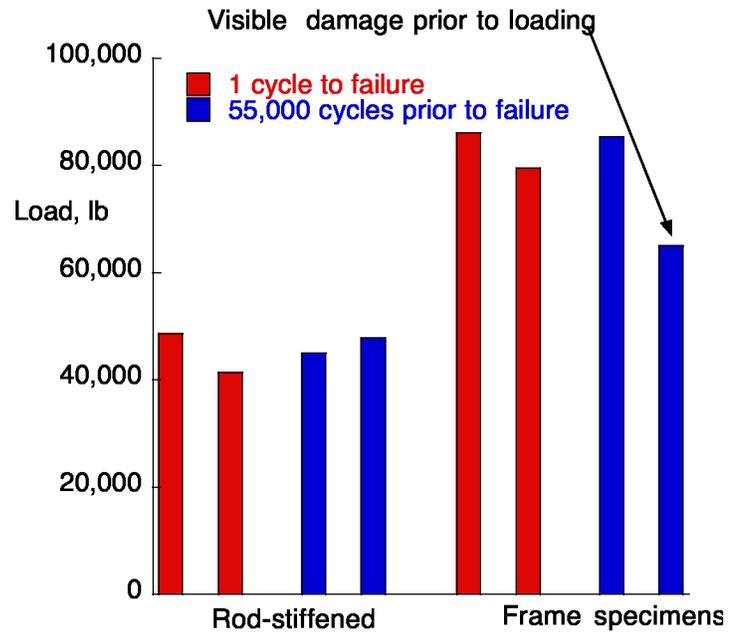
Figure 23. Failure loads.

Four specimens that were nominally identical to the specimens described herein were loaded in a single test to failure (ref 1). These specimens were cut from the same large panel as the fatigue specimens described herein and tested under the Boeing contract. The failure loads for the NASA-tested and Boeing-tested specimens are shown in table 3 and figure 23 for all eight specimens. Both fatigued rod specimens failed at loads greater than one unfatigued specimen but less than the other unfatigued specimen. Similarly, frame specimen F3 failed at a load greater than one unfatigued specimen but less than the other unfatigued specimen. The fatigued specimens failed in the same manner as the unfatigued specimens. There is no evidence the fatigue cycling had any effect on the failure loads of rod stiffened or frame specimens. Photographs presented in reference 1 show the same failures as seen in specimens R3, R4 and F3. No single-stiffener specimens discussed in reference 1 were damaged prior to loading so no direct comparison to specimen F4 can be made.

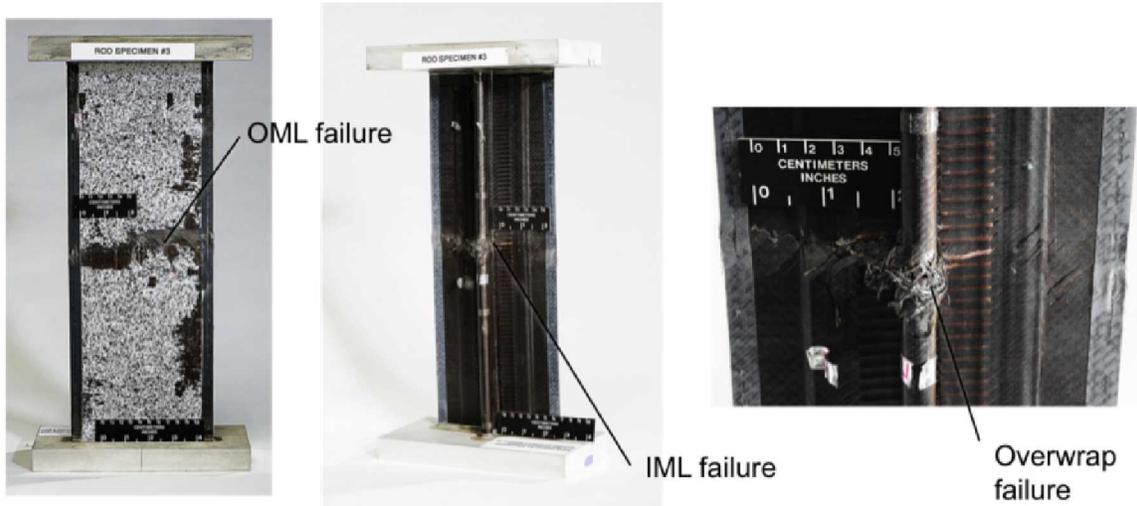
Figure 24. Rod specimen failure.

Rod-stiffened specimens failed midlength across the full width of the specimen. Minimal delamination can be seen between the flange and skin. Overwrap damage can be seen around the rod. Specimens R3 and R4 failed in the same manner. Frame specimen F4 was damaged prior to fatigue cycling but still withstood the cycling with no indication of damage progression and failed at a load equal to 78 percent of the failure load of specimen F3. Failure at the specimen corners and at the top of the location where the rod overwrap intersects the frame is evident in both specimens F3 and F4.

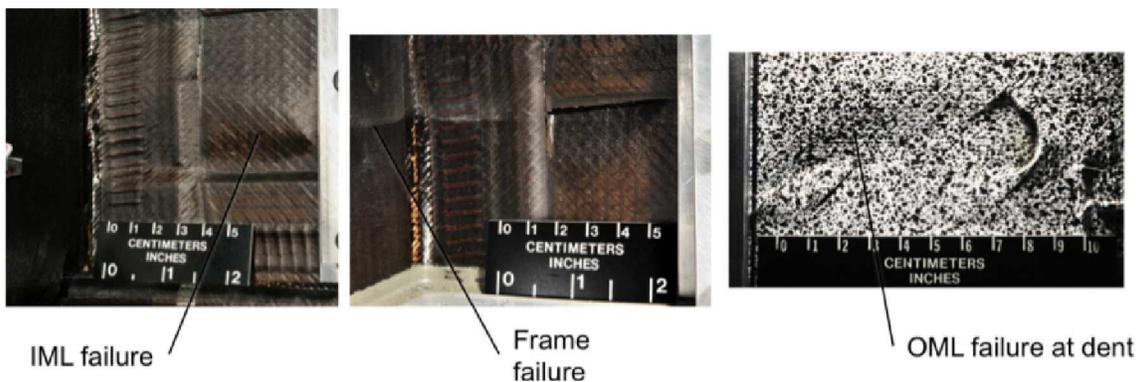
b) Specimen F4

Based on experimental evaluation of nominally identical single-stiffener compression-loaded specimens subjected one or 55,000 cycles of loading, fatigue cycling has no influence on failure load or mode. Visible damage to the skin of a specimen where the frame was loaded in compression reduced the failure load to 78 % of the failure load of the undamaged specimen.
